# Service Repair Handbook

( based on year 2006 models )

**Matsushita Electric Industrial Co., Ltd.**  
**Panasonic AVC Networks Company**  
**CS Promotion Cente**

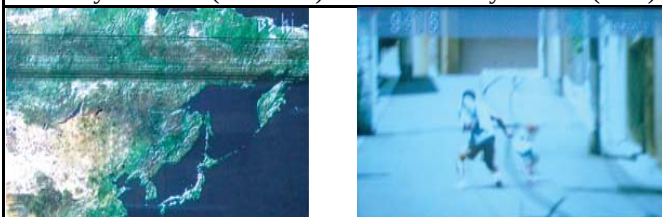
| Horizontal line<br>on upper side | Cause by SU PCB ( D PCB ) | | Cause by D PCB ( SU ) |

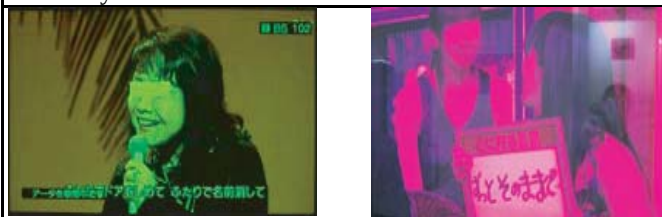
| monochrome error | Cause by D PCB | | |
| Yellowish or magenta | | | |

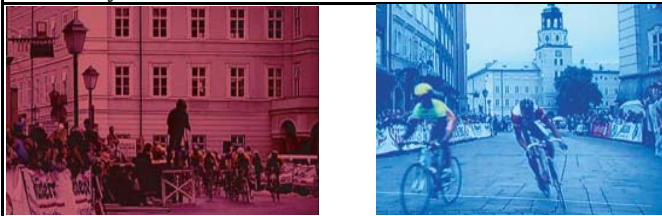
| | Cause by DG PCB | | |
| reddish or bluish | | | |

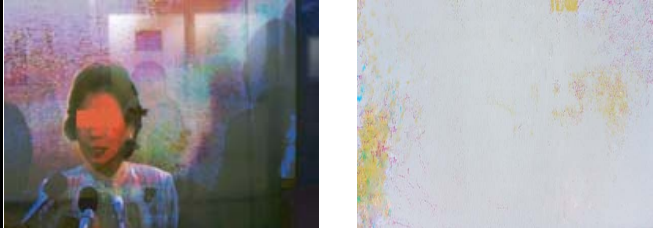
| Whole screen has radiation problem | cause by SC PCB ( D PCB ) |
| [ diagnostic point ]<br>When voltage charge does not match on scanning electrode and writing electrode, electric storage does not normal on inside cell of Panel.<br>and it does not radiate as normal operation.<br>therefore,<br>1. SC PCB what request order to scan electrode.<br>2. D PCB what control discharge.<br>those factor will consider cause of problem. | |

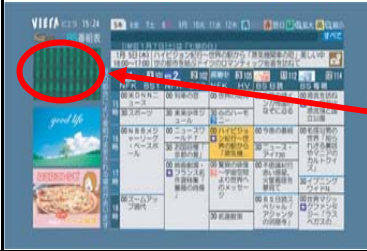
| Small screen problem | Cause by DG PCB |
| | TV channel program guide show and current TV program screen has problem. ( ex: PX 600 case ) |

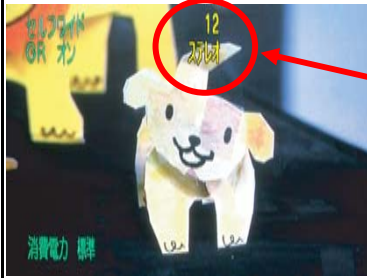
| OSD position wrong | cause by DG PCB |
| | OSD indication position is wrong |
